TECHNICAL REPORT HL-80-10

# OCEANSIDE HARBOR AND BEACH, CALIFORNIA DESIGN OF STRUCTURES FOR HARBOR IMPROVEMENT AND BEACH EROSION CONTROL

Hydraulic Model Investigation

Hydraulics Laboratory  
U. S. Army Engineer Waterways Experiment Station  
P. O. Box 631, Vicksburg, Miss. 39180

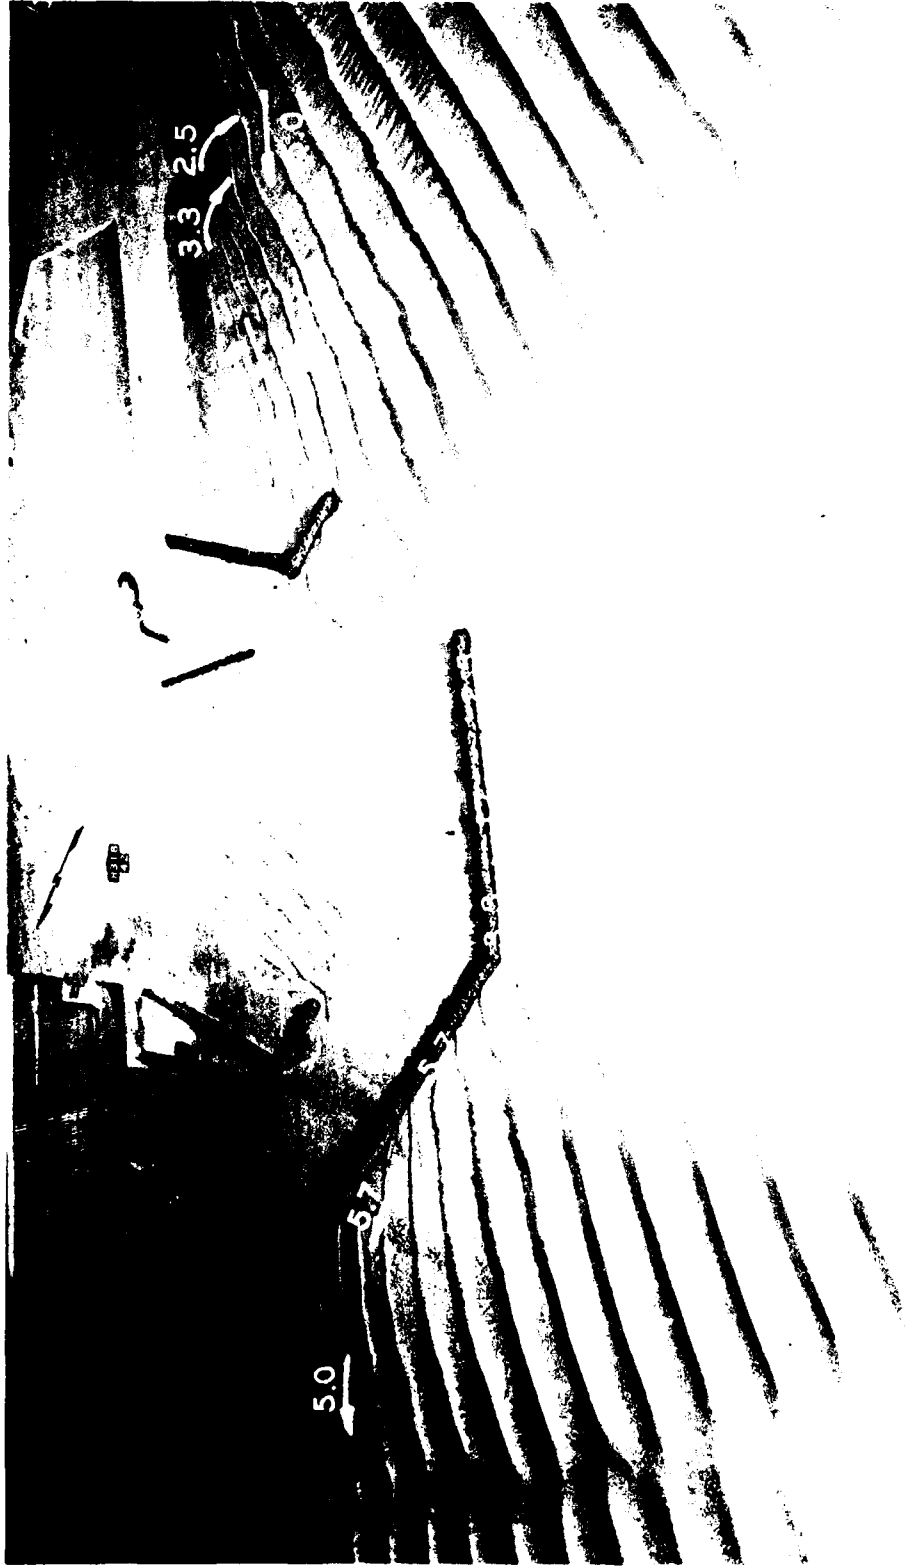
Photo 4. Typical wave and current patterns and current magnitudes (prototype feet per second) for existing conditions; 9-sec, 10-ft waves from south at mllw

along the inner end of the north jetty. Currents in the vicinity of the harbor entrance were generally confused with rip currents and eddies forming to the south. In general, currents for waves from the south deepwater direction (Photo 4) were characterized by strong longshore currents moving past the end of the south groin, across the harbor entrance, and along the north jetty. In general, for all waves, currents were stronger for tests conducted at mllw than at mhhw. Considerable overtopping of the north jetty was observed at mhhw. Wave-generated currents inside the harbor were very slow.

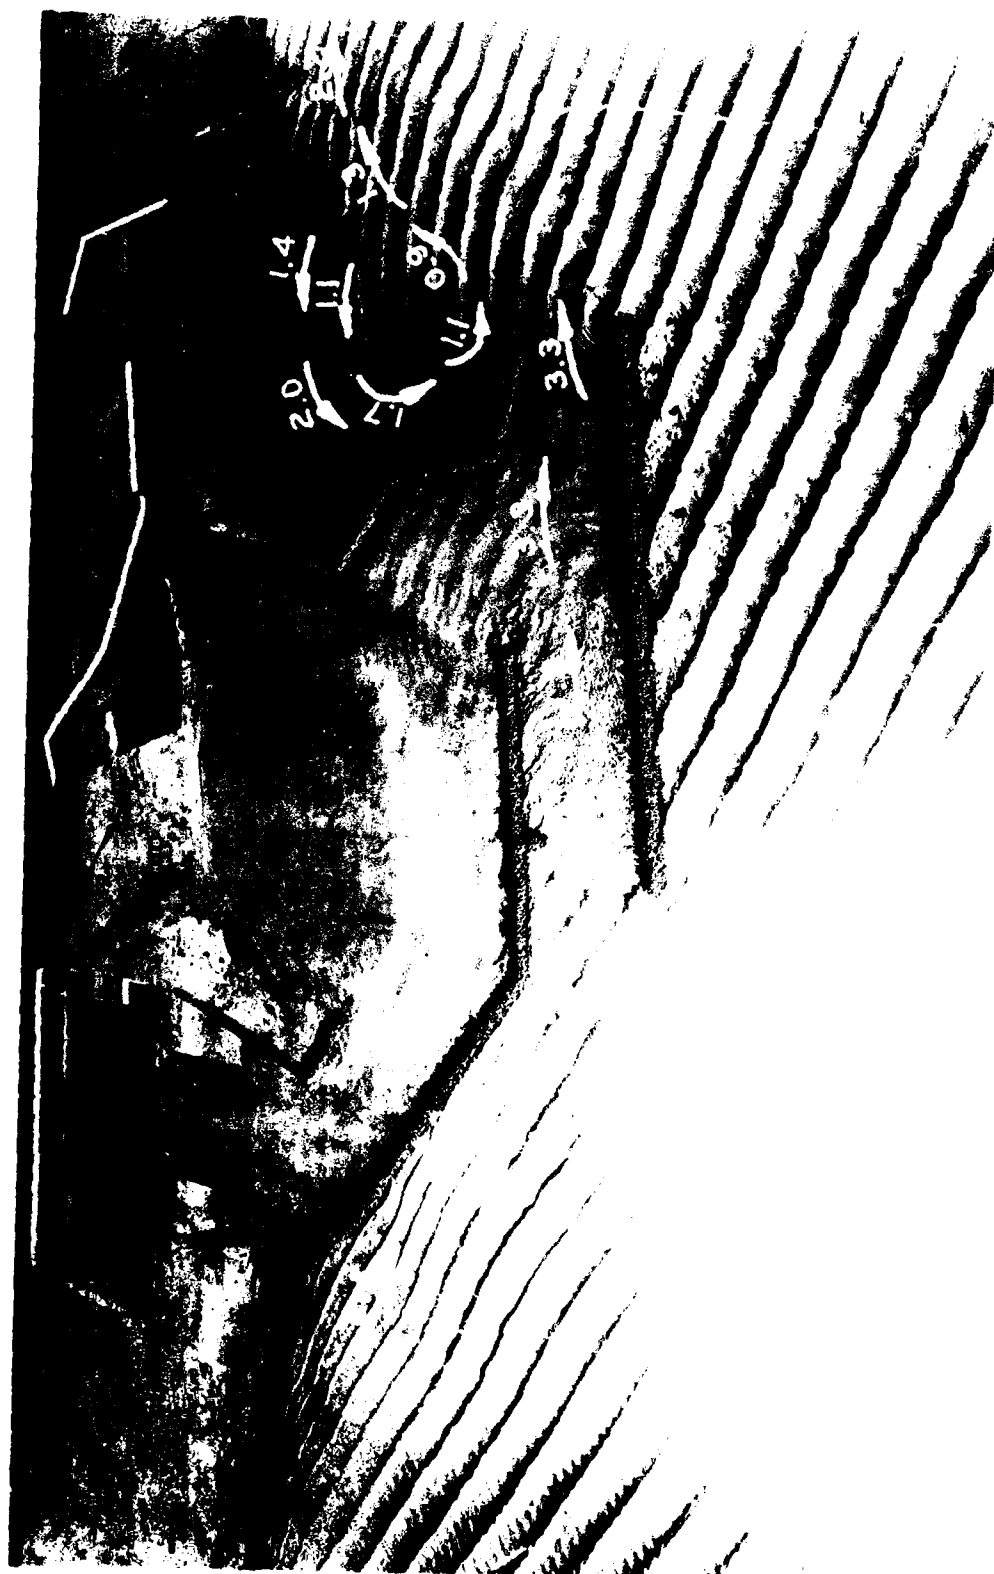
Photo 11. Typical wave and current patterns and current magnitudes (prototype feet per second) for Plan 4; 7-sec, 10-ft waves from northwest at mllw

54. Current patterns and magnitudes for Plan 4 for waves from the northwest deepwater direction (Photo 11) exhibited moderate longshore currents along the north jetty, which moved into the lee of the offshore breakwater and exited between the offshore breakwater and south jetty extension. For waves from the west deepwater direction (Photo 12), a rip current formed at the shoreward terminus of the north jetty as for existing conditions. However, the 2200-ft-long offshore breakwater and 100-ft-long stub intercepted the southerly flowing longshore currents with the stub forcing them into deeper water. For waves from the southwest deepwater direction (Photo 13), northerly longshore currents formed along the north jetty. Currents in the vicinity of the harbor entrance were generally slow and confused, with eddies occurring to the south of the south jetty. For waves from the south deepwater direction, the strong longshore current moving past the harbor entrance for existing conditions was forced to eddy due to the addition of the 400-ft-long dogleg to the proposed south jetty extension. Exceptions were for the 7-sec, 10-ft and 9-sec, 10-ft waves at mllw (Photo 14), which were characterized by strong rip currents moving southerly past the dogleg. In general, for all waves, currents were stronger for tests conducted at mllw than at mhhw. Currents inside the harbor remained very low.
